## DOLPHINS – VISUAL STRUCTURAL INSPECTION

Brightlingsea Harbour

Brightlingsea Town Council

April 2021

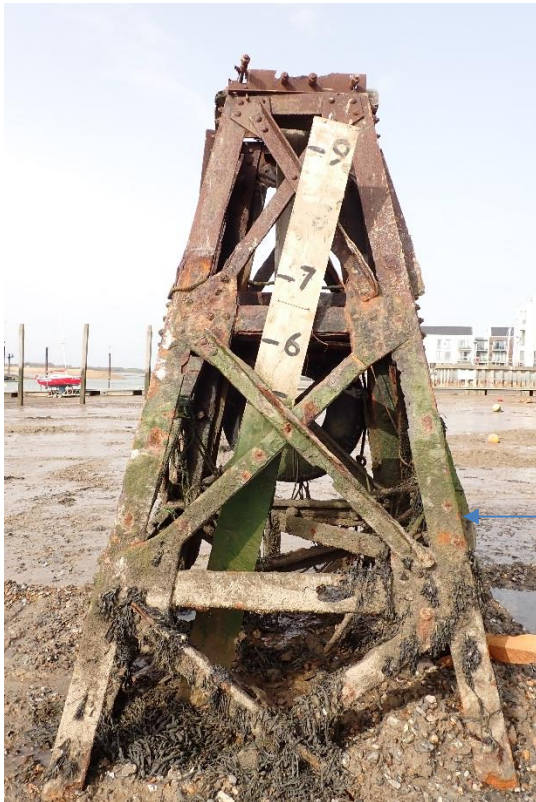
Fig 3 – Dolphin 2

Approximate High Tide Line

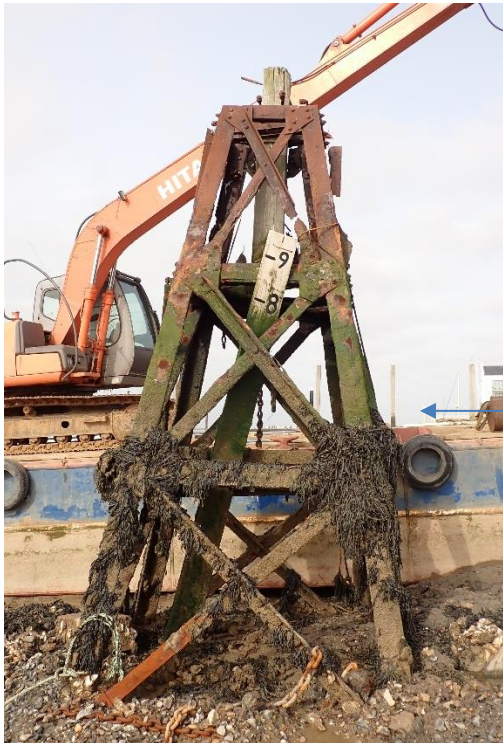
Fig 4 – Dolphin 3

Approximate High Tide Line

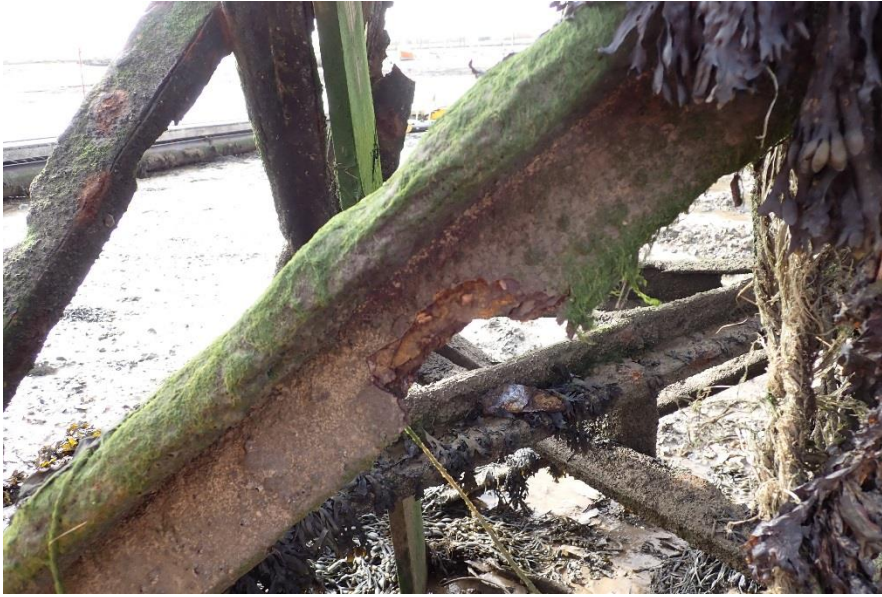
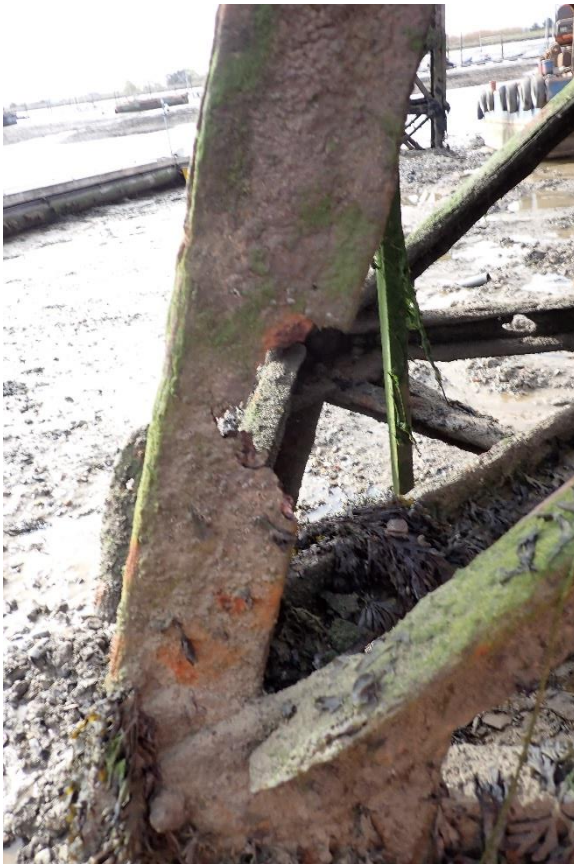
- 4.5. Above the tide line all members examined had no sectional thickness remaining; striking with a 500g hammer resulted in complete local disintegration of the member.

Fig 5 & 6 – Results of hammer testing on Dolphin 1

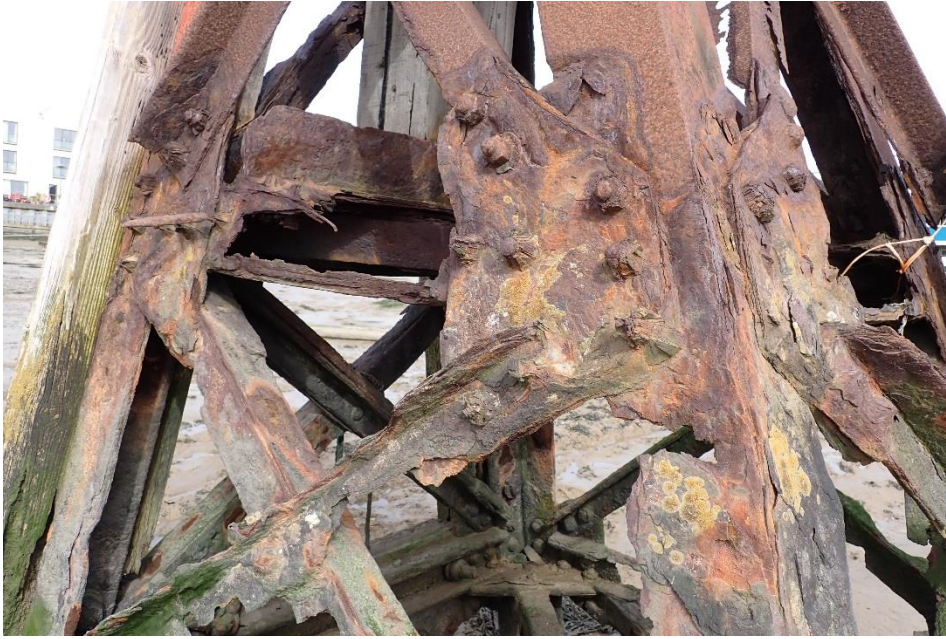
Fig 7 - Typical condition of joints on Dolphin 1 above high tide line

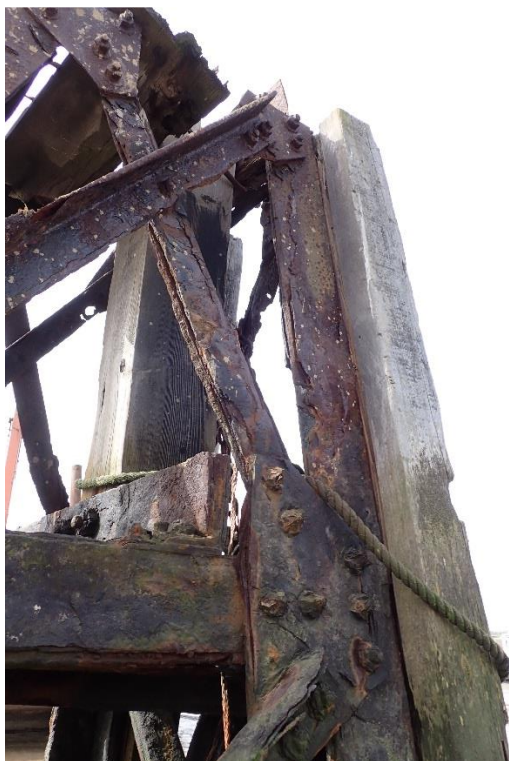
- 4.3. On all 3 No. moorings, above the high tide line, the steel members were heavily corroded. Some individual members had completely dissolved and others exhibited large holes.

Fig 8 - Upper section of Dolphin 2 (note extreme loss of section)

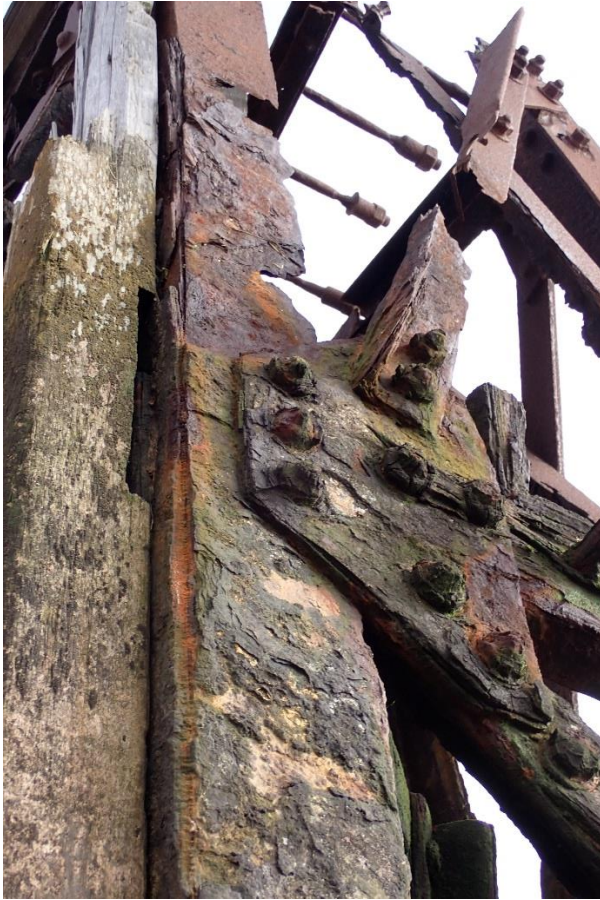
Fig 15 – Dolphin 3 above high tide line note deterioration of connections

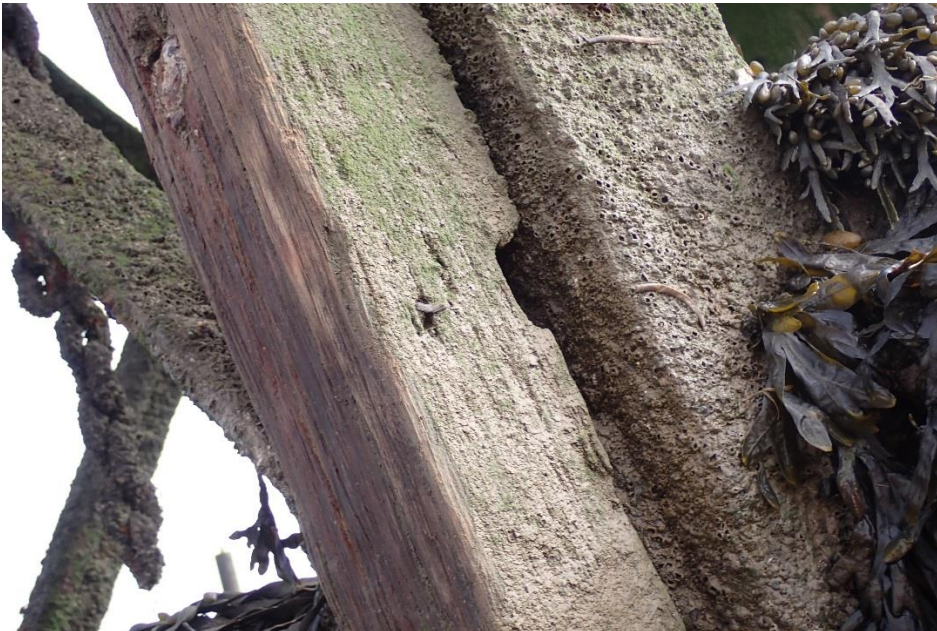
Fig 16 – Dolphin 3 typical condition of hardwood timber rubbing rail

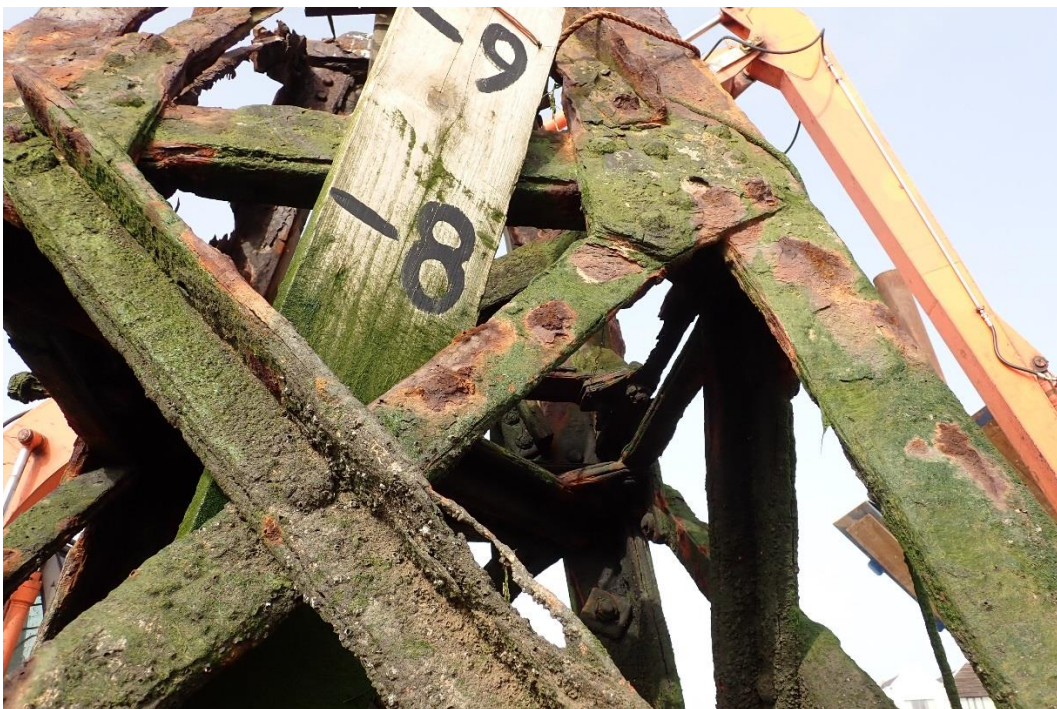
Fig 18 – Dolphin 3 typical condition note hole in diagonal bracing member

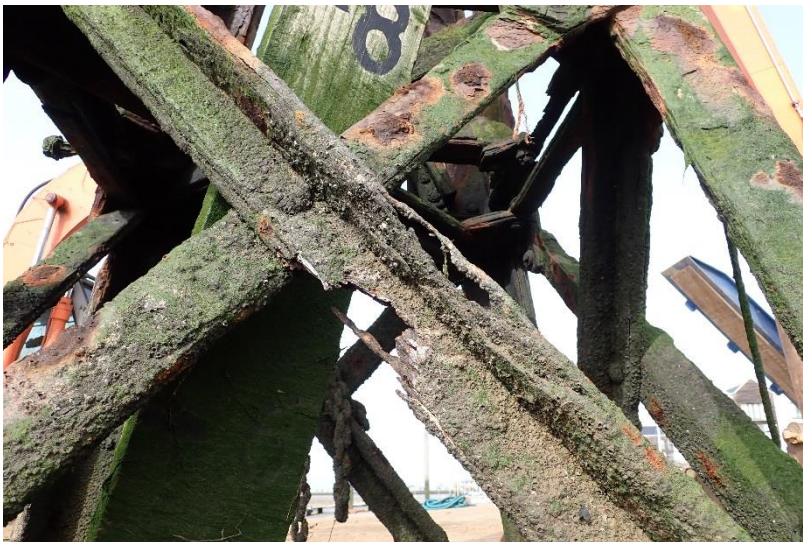
Fig 20 – Dolphin 3 typical condition of members at high tide line

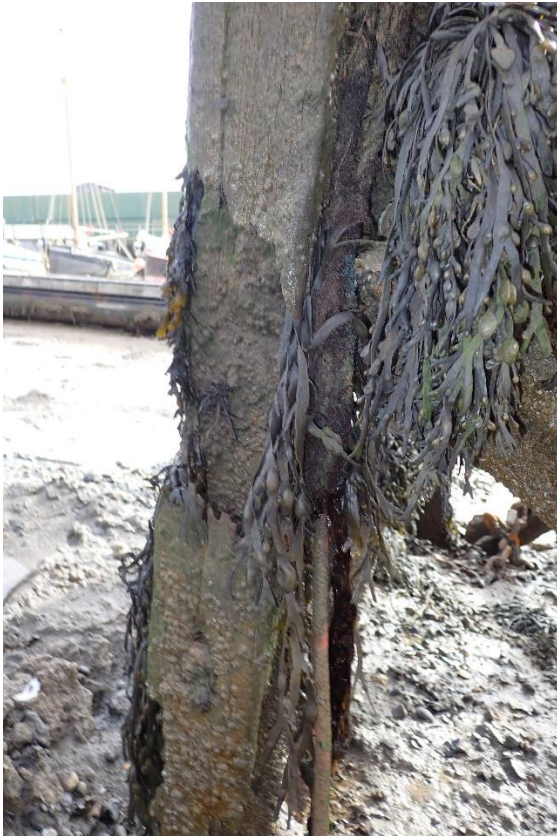
Fig 21 – Dolphin 3 loss of section of timber rubbing rail and poor condition of connection bolt

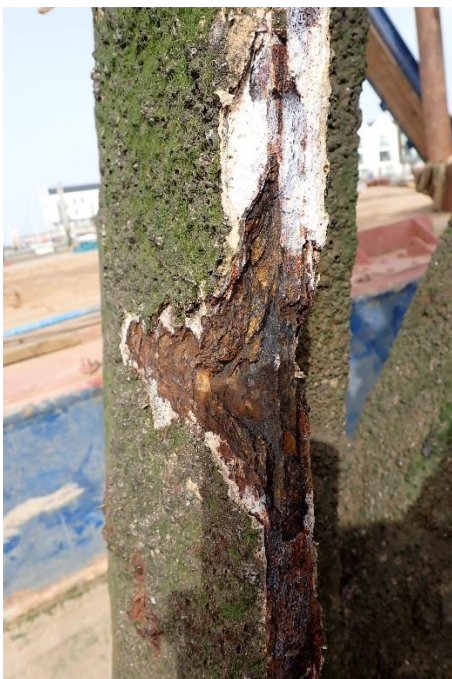
Fig 22 – Dolphin 3 condition of member under marine growth

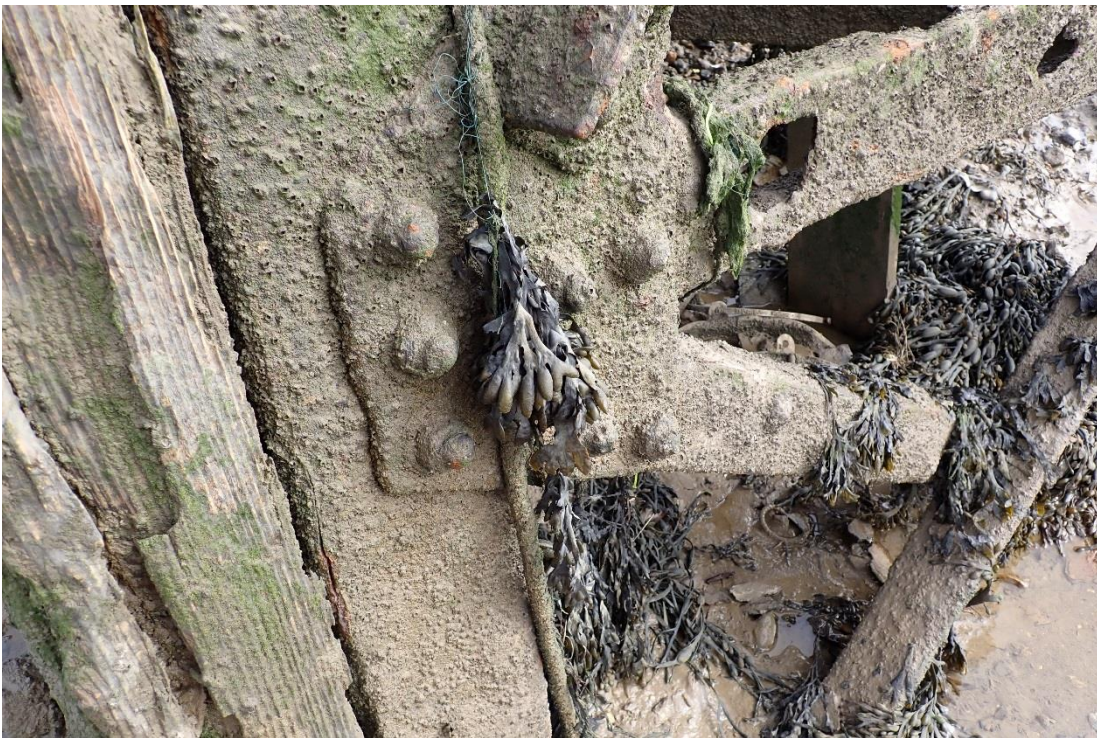
- 4.4. Hammer testing was undertaken upon various members. Below the high tide line following removal of the marine growth the steel was preserved. The marine growth of barnacles particularly on No. 3 was very thick and uniform and had in places completely encased the members below the high tide line (an approximate height of 1.3m).

Fig 24 - Dolphin 3 typical marine growth below tide line

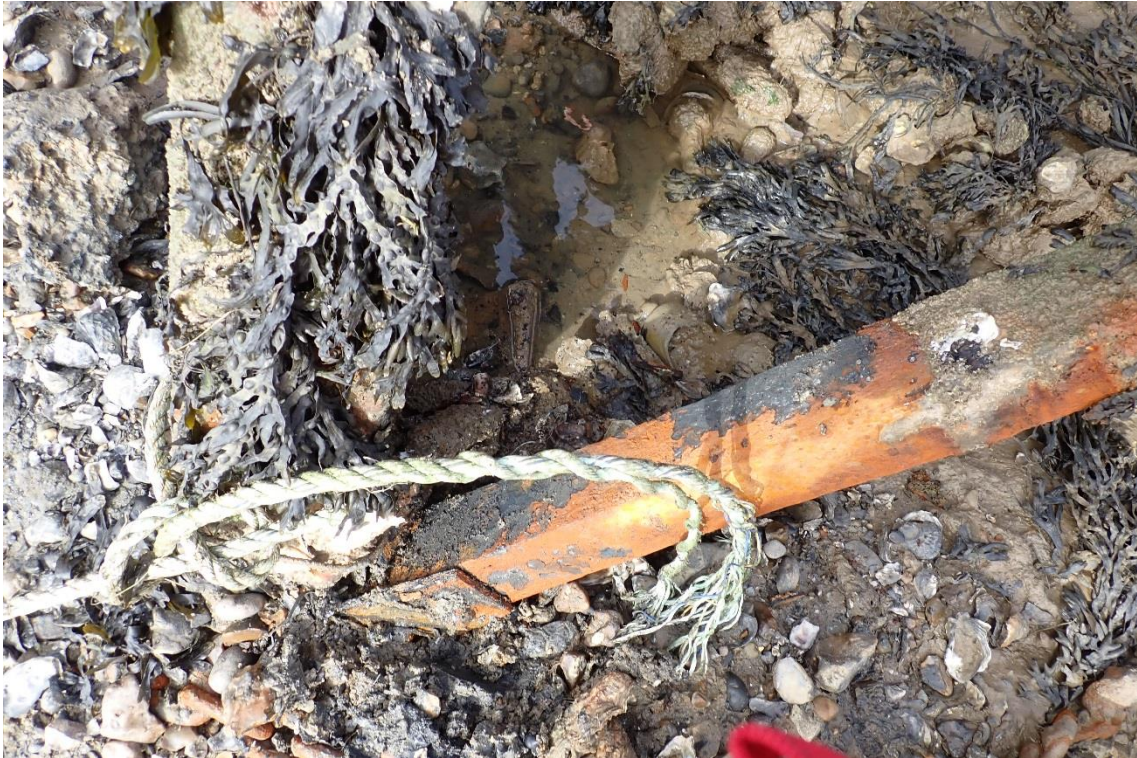
- 3.6. The horizontal members were 5.5" x 2.5" PFC (140mm x 64mm) (following removal of the marine growth and corrosion).
- 3.7. The plated joints are a mixture of riveted and bolted connections (where possible to differentiate). The measured thickness of the plate at the mud line on No.3 Dolphin was 12mm.

Fig 25 - Dolphin 3 at mud line following removal of marine growth
